## Evaluation Of The Transverse Strength Of Denture Base Resins Repaired With Conventional Heat Cure Or Autopolymerising Resins Under Different Surface Treatments- An In Vitro Study

**Abstracts:** Aim: Acrylic resin dentures are susceptible to fracture after clinical use. The denture repair should be easy, strong and should not affect the dimensional accurac. Objective: The study was conducted with an objective of evaluating the transverse strength of two types of heat cure resins when repaired with different types of heat cure and autopolymerizing acrylic resins under different surface treatments. Methods: 195 rectangular specimens (65.0 x 10.0 x 3.3mm) of DPI-Heat Cure and Acralyn H were fabricated according to ADA Specification No.12, and stored in distilled water at room temperature for 7 days. 15 specimens of each material remained intact (control). 180 specimens of each material were sectioned in the middle to create a 10mm gap. 60 specimens each were treated with different surface treatments like wetting with methylmethacrylate monomer for 180sec and air borne particle abrasion for 5sec and 60 specimens were repaired without any surface treatment. Among these 60 specimens,

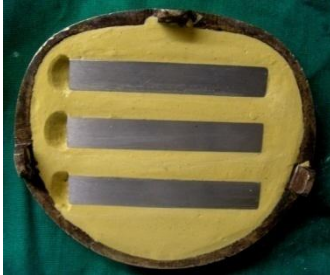
**Figure 1: Investing metal dies**

Type III dental stone was used to invest metal dies (as done in compression molding technique). Before investing, the metal dies were coated with a thin layer of petroleum jelly (Bioline) for easy removal of the die once the dental stone had set. For easy removal of the metal dies, without fracture of the molds, a space was created on one side of the metal dies in the first pour of dental stone (fig 1). The space allowed for easy retrieval of the metal dies once the second pour had set completely. A layer of cold mold seal was applied before trial as well as final closure.

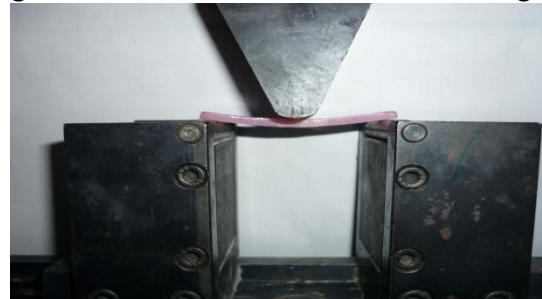
**Figure 3: Measurement of Transverse Strength**

The transverse strength of the repaired and the intact specimens were measured using a 3 point bending test in a Universal testing machine with a 10000 kg load cell at a cross head speed of 5mm/min (fig 3).

The transverse strength(s) of each specimen was determined using the formula

$$S = \frac{3WL}{2bd^2}$$

where W - the fracture load, L - The distance between the supports (50.0 mm)
